CANADIAN FORCES FLIGHT SAFETY INVESTIGATION REPORT (FSIR)

FILE NUMBER: 1010-CH12419 (DFS 2-4-2)
DATE OF REPORT: 5 August 2005

AIRCRAFT TYPE: CH124A Sea King
DATE/TIME: 21 1115 Z August 2003
LOCATION: 26° 24' N 55° 53' E (Straits of Hormuz)
CATEGORY: "D" Category Incident

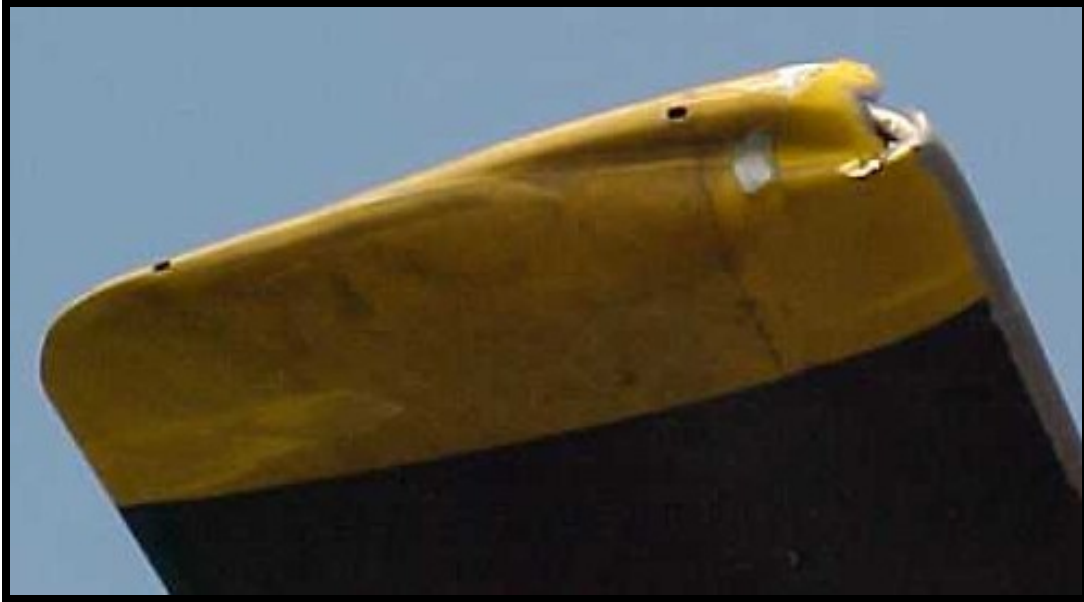
The rotor blade tip caps of the number one and number five blades were damaged and exhibited signs of rippling and deformity (Photo 1). An inspection for sudden blade stoppage was also conducted. This inspection involved a comprehensive review of the main rotor head, main rotor blades, main gearbox, engines, and tail rotor drive shaft, and determined Class 2 damage to be apparent. Class 2 damage is defined as light to heavy damage that requires

blade removal and is repairable by local resources or at overhaul level. The damage was originally classified as “C” category and was later reclassified as “D” category.

Photo 1: Blade Tip Damage

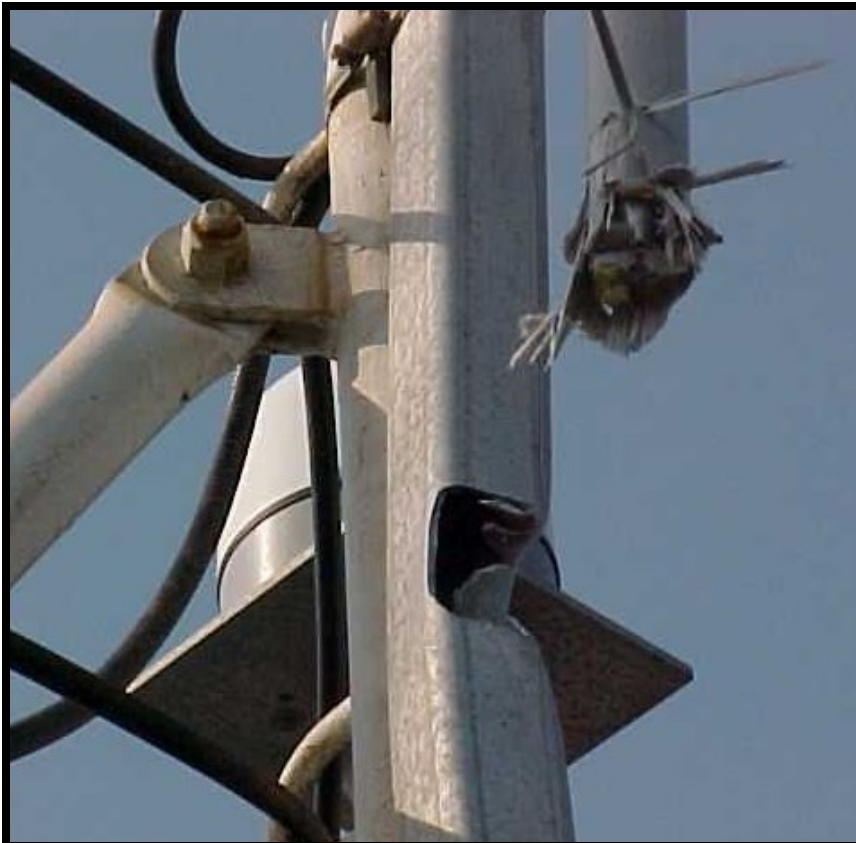
The blade strike resulted in relatively minor collateral damage to HMCS CALGARY’s upper bridge structure on the starboard forward position approximately 40’-42’ above the waterline. A fibreglass VHF antenna and an aluminium guardrail corner-post were sheared (Photo 2). Antenna and guardrail pieces were scattered on the bridge wing and the starboard boat deck.

Photo 2: Stanchion and Antenna Damage

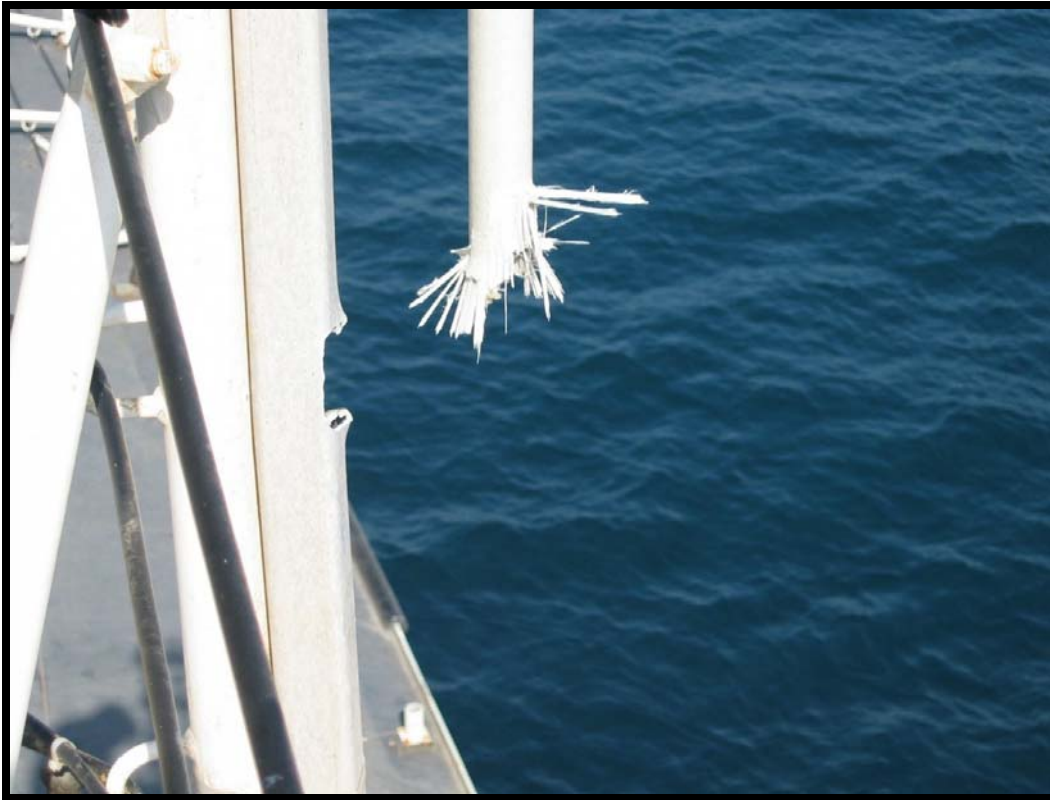
The damaged railing (Photo 3) indicates a cut angle of approximately 20°, which approximates the bank angle plus or minus blade coning and flapping angles. Based on a 20° bank angle and a 31' blade length, the blade tips struck the guardrail at approximately 42' above the water line; the fuselage was approximately 10' higher at 50' ASL.

Photo 3: Blade Cut Angle on Stanchion and Antenna
